**POPULAR HOT RODDING** WPS

# TURBO 400 TRICKERY

Making The Turbo 400 Transmission Better

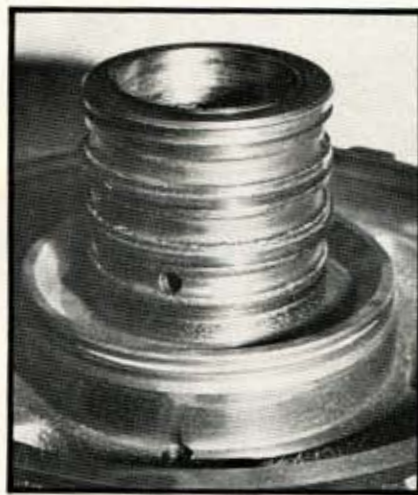
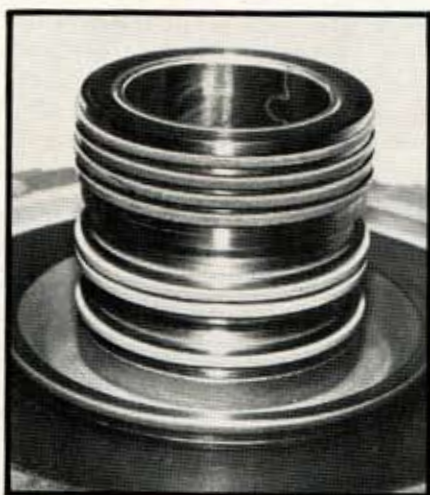
One of the major problems with Turbo 400 transmissions concerns sealing between center support housing and high gear clutch drum. In stock configuration, four steel piston-ring style rings are located on the center housing. When high gear clutch drum is in place rings expand—with first three rings directing the flow of transmission fluid to the high gear clutches. Last ring directs flow of fluid to second gear sprag clutch. Advanced Transmission remachines center housing collar, installing seven Teflon rings to give more support for clutch drum—not allowing it to walk around and lose fluid. First five rings direct fluid to second gear clutch sprag. Teflon rings are resistant to hot oil temperatures, fine metal in the fluid, high line pressures, and sealing problems.

Jim Galatioto of Advanced Transmissions (11235 Coloma Road, Unit G, Rancho Cordova, CA 95670 916/635-2525) has developed a few items which alleviate these problems. By using Teflon sealing rings instead of the stock metal units and replacing the thrust washers with Torrington bearings, the transmissions run cooler with less leakage and can withstand the increased line pressures which often accompany the installation of an after-market shift kit.

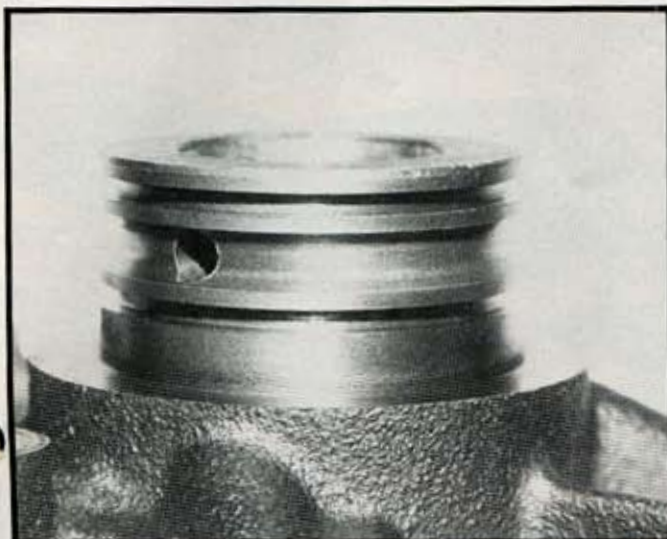
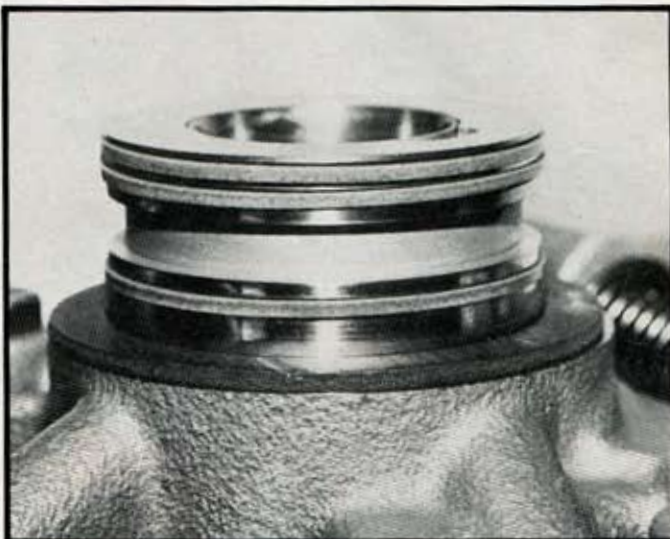
Stock pump forward clutch apply hub also uses metal rings to seal it to center support housing as is found with center support housing clutch drum connection. Advanced Transmission substitutes Teflon rings here as well.

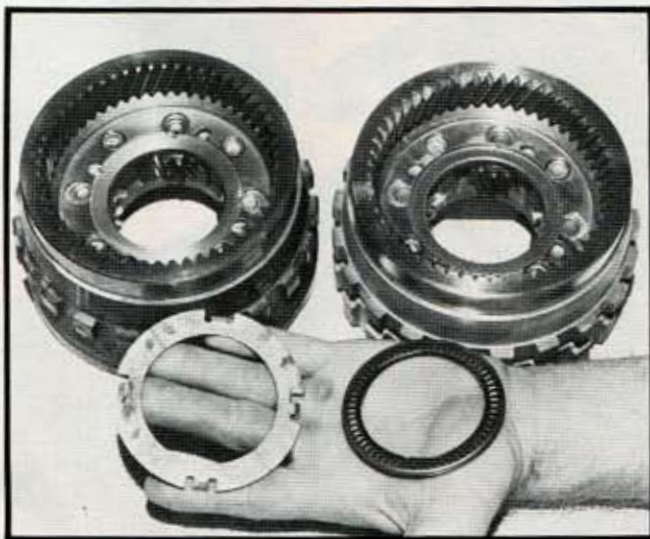
A similar needle bearing is used in rear planetary output carriers (shown here) and forward clutch drive hub.
