FUEL SAVINGS FOR TRUCKS

MISSIONS

That's right transmissions can save you money.

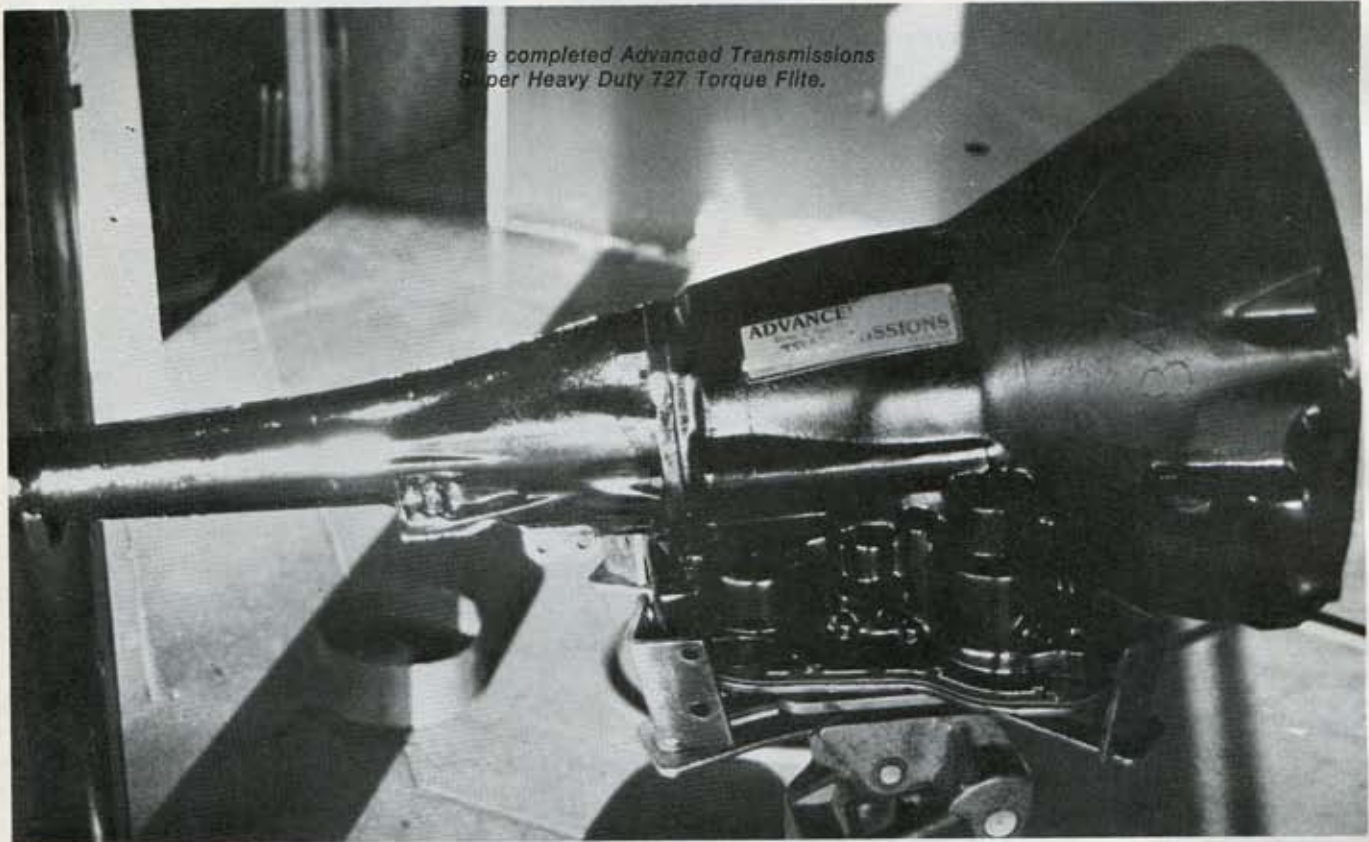
The completed Advanced Transmissions Super Heavy Duty 727 Torque Flite.

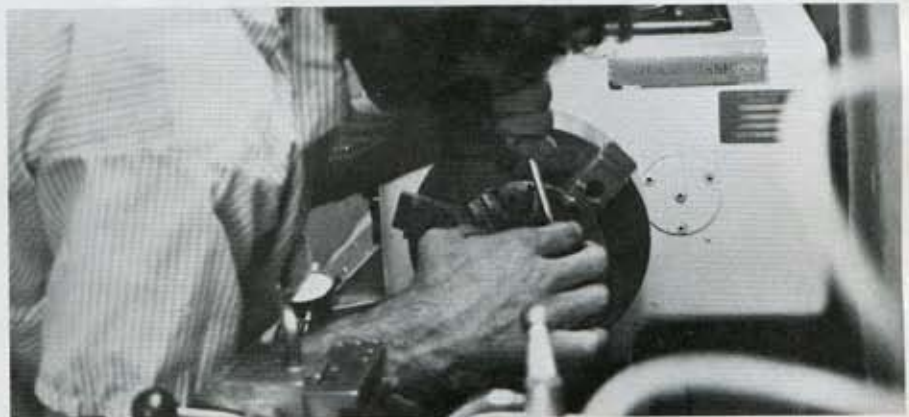
Reaction shaft is machined to accept the Teflon ring.

Another longevity move has to do with the pump reaction shaft. A Teflon "O" ring is installed in the back of the shaft to act as a buffer supporting the high gear clutch drum. Without this, wobble develops which wears out and destroys the two sealing rings. The back of the reaction shaft is drilled with a 1/8" drill to add more lubricant to the shaft for longer life.

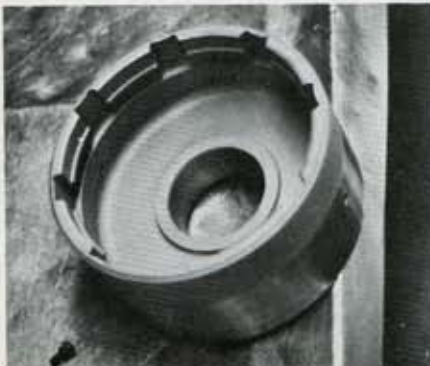
The reverse drum is drilled to add more oil from the main shaft to the rear band.

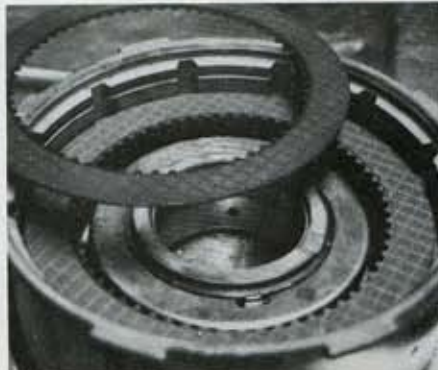
Raybestos clutch material is used in the direct clutch.

When the trans goes back together, Raybestos clutches are used instead of paper, which is a big improvement, and a Redline intermediate band is used.

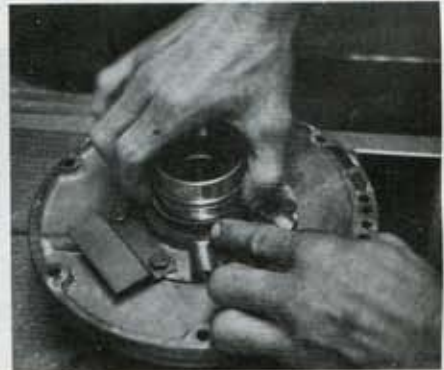
Installing the sealing rings for the direct clutch drum.

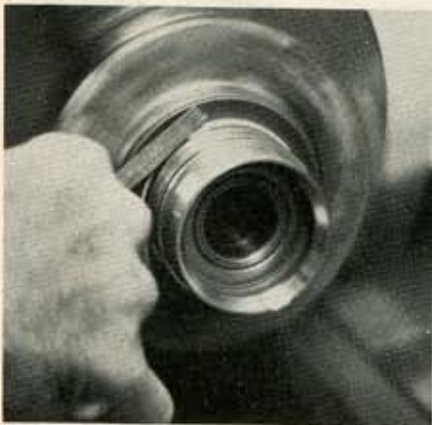
The support ring is hand shaped with a file.

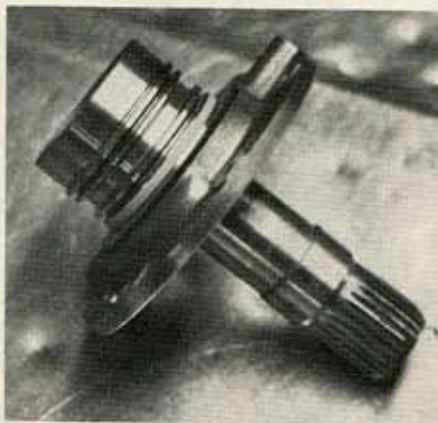
Installed Teflon ring on reaction shaft.

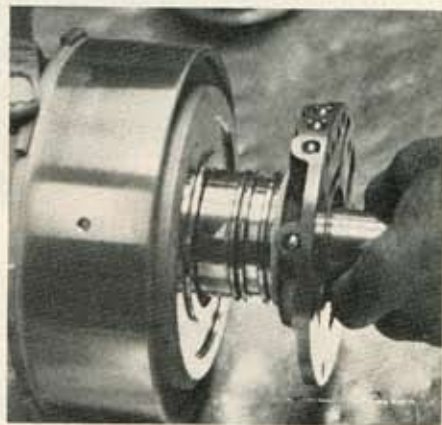
The reaction shaft support ring must fit the I.D. in the direct clutch drum within specs.

Finally, the high gear clutch drum-band surface is machined for better surface to improve band hookup and the I.D. of the drum is polished to reduce friction on the rings and Teflon "O" ring on the reaction shaft.

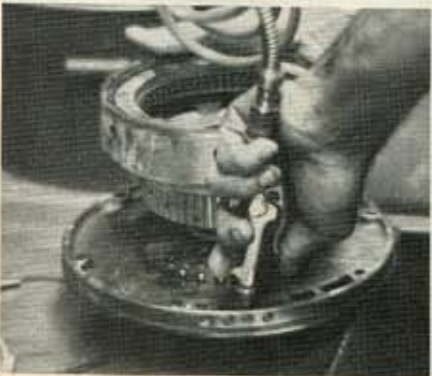
Pressure is used to test clutch position in the direct clutch.

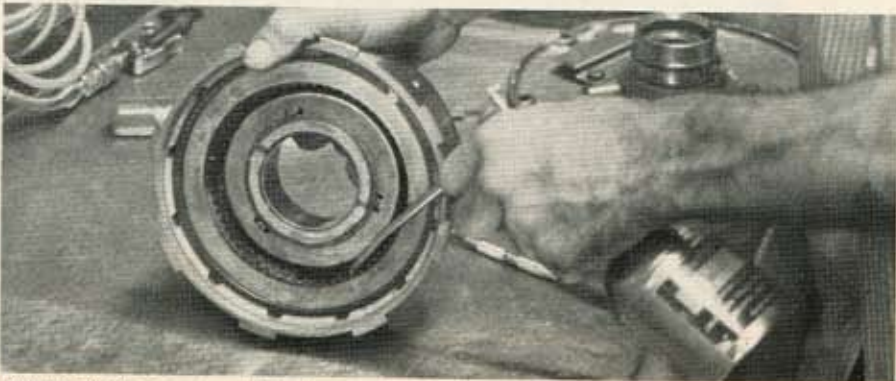
All clutch areas are pre-lubed.

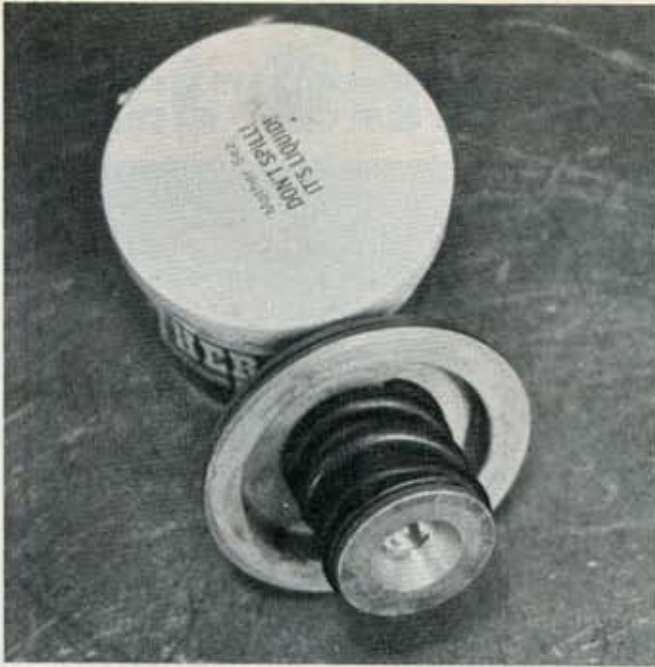
Reverse band-apply piston before removing spring.

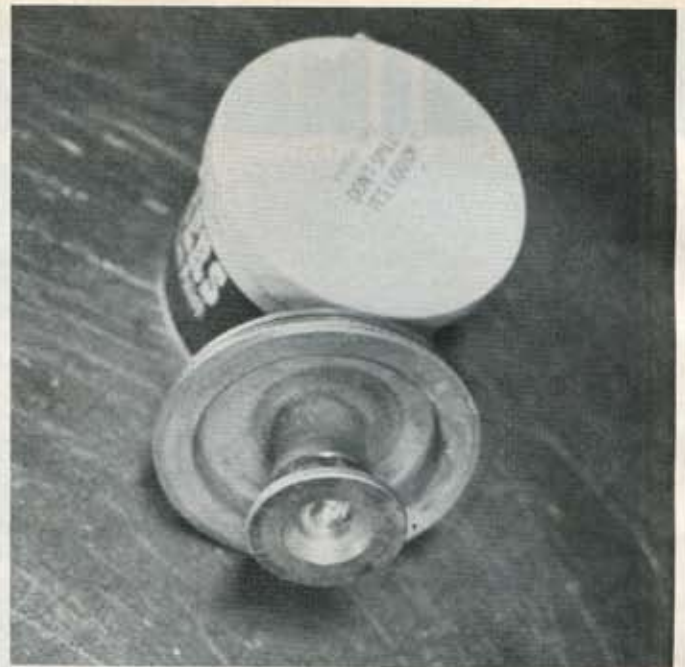
Reverse piston spring is removed to stop lock-up from manual low to 2nd gear.

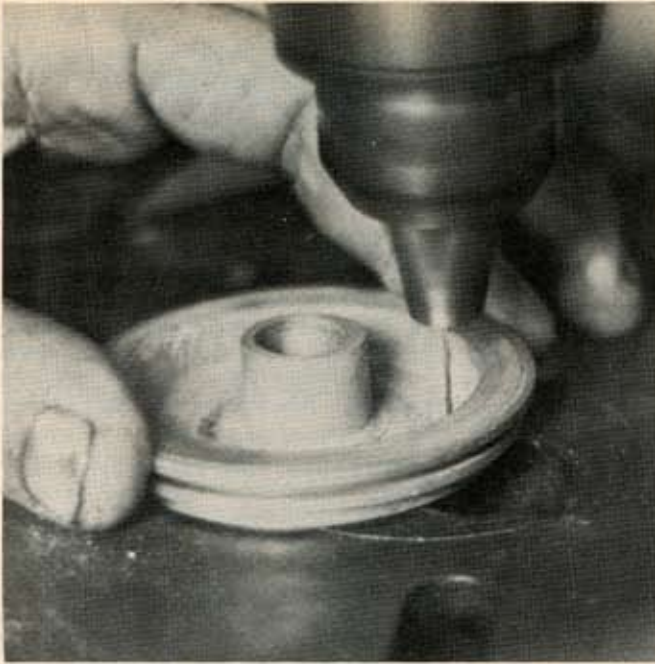
Reverse piston is drilled to release 25 percent of the pressure to prevent band breakage.
