ORV

THE BULLDOG TREATMENT

or How to make a Turbo 350 live.

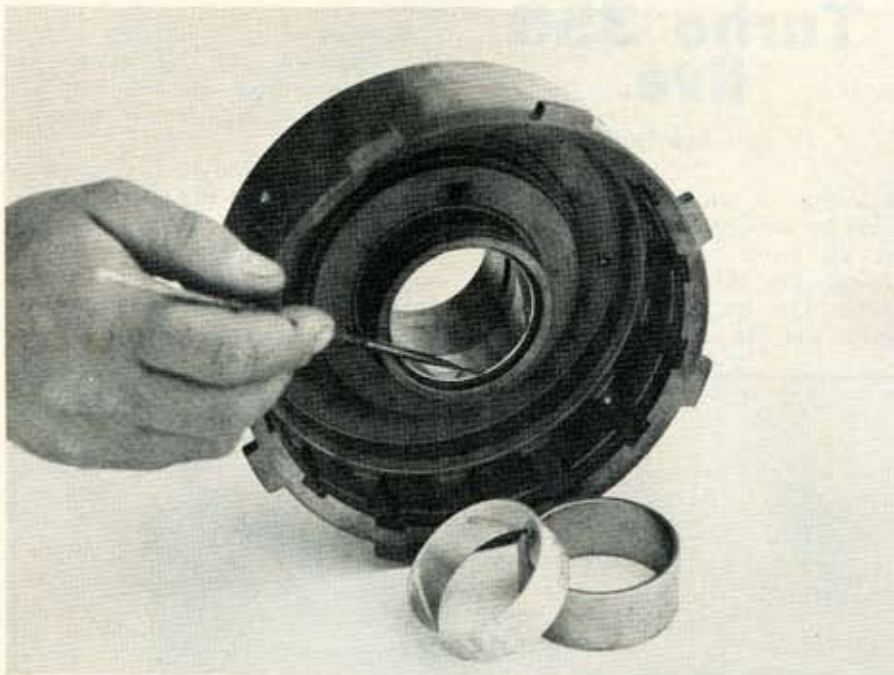
Bearing area is enlarged inside drum and new bearing is added. Top quality bushing materials are used throughout.

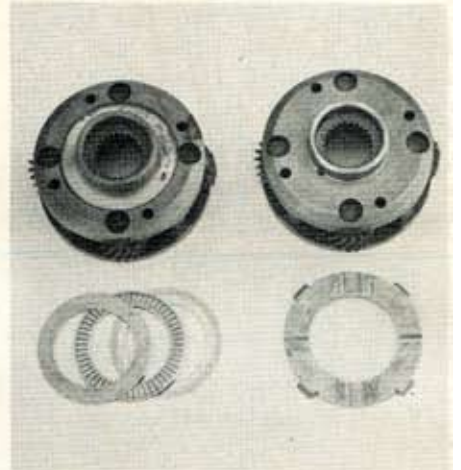
The stock babbitt thrust washer on the front planetary assembly is just one of five which are replaced with roller bearings in the Bulldog transmission, eliminating heat and wear problems.

Any source of heat build-up in an automatic transmission is a potential problem. In stock form, the Turbo 350 has a number of thrust washers where heat can be created. Jim's Bulldog has a total of five different areas where thrust washers have been replaced with

very high quality roller bearings, once again eliminating a source of trouble.

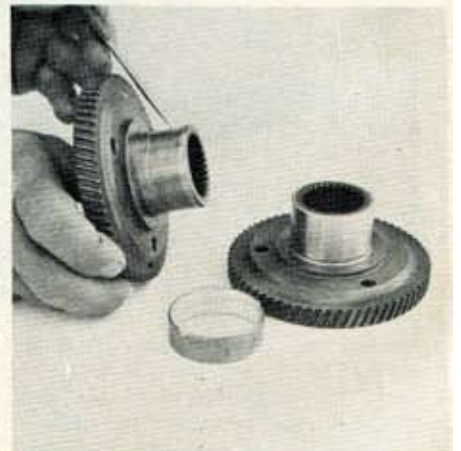
Output shaft retainer has a bushing surface which is subject to considerable wear. New retainer (right) has hard-chromed surface which eliminated problem.

The output shaft retainer has a bearing surface on it which also tends to wear. Jim replaces the retainer with one which has had the bearing surface hardchromed, eliminating the wear.
